CLIMA 2016 - proceedings of the 12th REHVA World Congress

Indoor climate quality after renovation for improved energy efficiency

Lars Gunnarsen^{#1}, Sebastian Løck^{*2}, Barbara Kolarik^{#3}, Jakob Klint^{#4},
Philippe Scanlon^{#5} and Gert Rønnow^{*6}

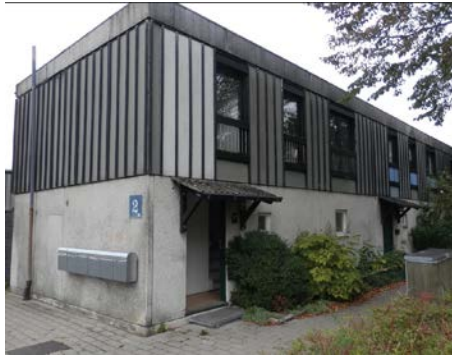
Figure 1. Facade picture of Albetslund Syd before renovation.

Albertslund Syd. Attached houses with two floors erected in 1963-65 including 94 buildings. Typically one building includes 6-7 dwellings of 98 m². The case includes a total of 550 dwellings. The renovation works were very comprehensive. Buildings were torn down with only concrete walls on first floor and foundations remaining and then rebuild according to present standards.

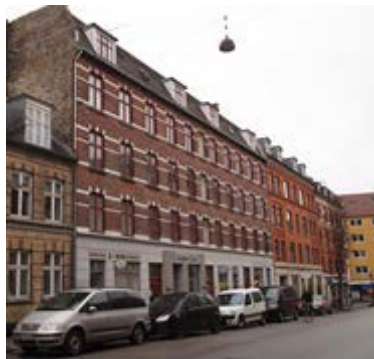
Figure 2. Facade picture of Gl. Jernbanevej before renovation and as of today.

Gl. Jernbanevej. One block of flats with 5 floors erected in 1899 with brick walls. First floor accommodates shops. Other 4 floors have a total of 16 flats on 1139 m² floor area. Flats have an average floor area of 71 m². It is the intention to add one more habitable floor on the roof level and use the generated revenue to finance an extension of the building envelope with added floor area, window area and insulation on the back side of the building. The renovation works was delayed and not initiated while the project was ongoing.

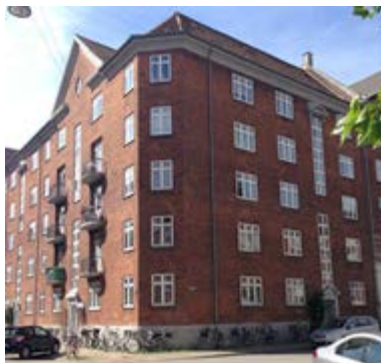
Figure 3. Facade picture of AB Bustrup.

AB Bustrup. One block of flats with 5 floors erected in 1918 with brick walls and a total floor area of 5585 m². The block has 87 flats and the average floor area of one flat is 64 m². The renovation only included exchange of windows and some mounting of new balconies.
